# **Hyperbaric Chamber Fires: Lessons Learnt**

**Dick Clarke, CHT**

Primary Training in Hyperbaric Medicine  
Columbia, South Carolina

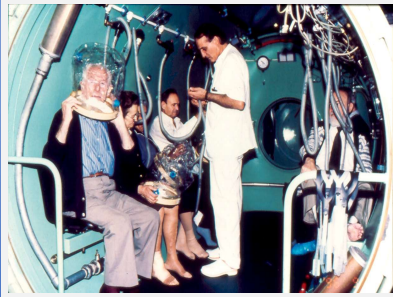
Multiplace chamber Milan, Italy  
 personal clothes; synthetics/pockets  
 no pt. or IA checks...pockets  
 hood exhaust system disconnected  
 "improperly modified hood latex neck seals allowed O<sub>2</sub> to escape into pt. clothes making patients flammable cylinders"  
 chamber O<sub>2</sub> concentration commonly exceeded permissible limit  
 "O<sub>2</sub> monitor alarm manipulated"

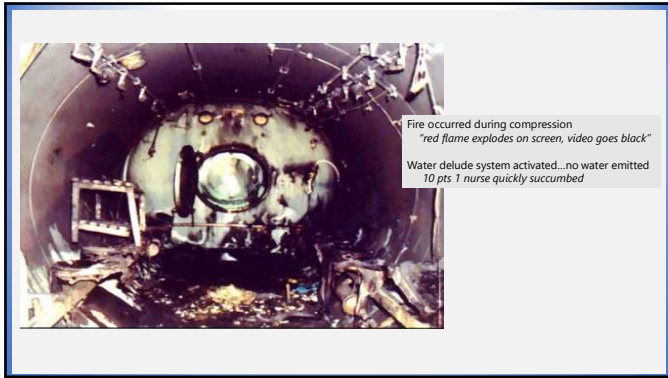
**10 patients and nurse die within seconds in hospital fire**

Fire lasted ~ 30 seconds

"A lady enters the hyperbaric chamber where she is to undergo treatment and brings with her an alcohol-based hand warmer, those with flame. From that hand warmer starts the fire that kills, after a slow agony, all the people who were inside."

"The fire extinguishing system was not functioning as the tank that was supposed to contain the water was empty, the propellant compressed air cylinder had the tap closed and the water supply hose valve was closed. The hand shower inside the hyperbaric chamber, foreseen in the design phase, had not been installed."

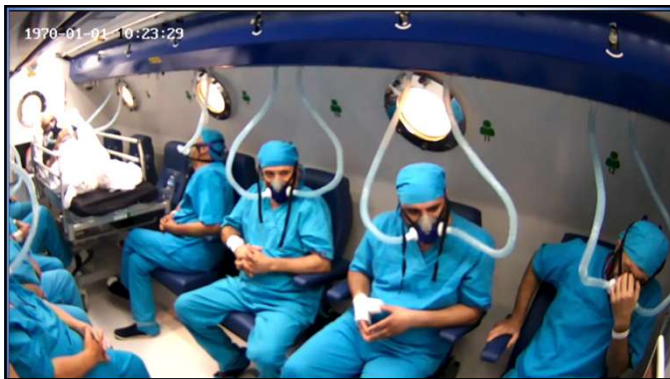
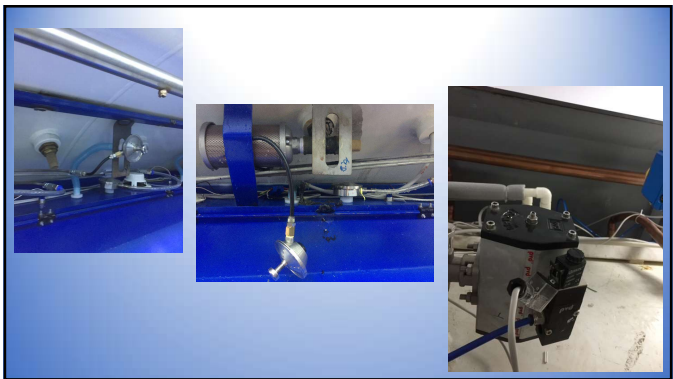
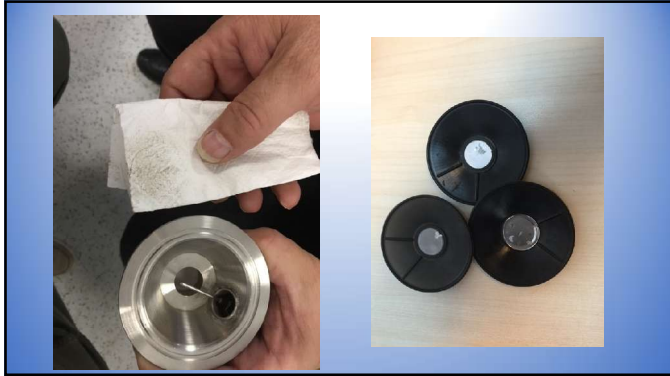
Two "lightsaber-like" oxygen flames seen emitting (via viewport)  
*spontaneous ignition within regulators*

Chamber operator did not/could not activate water deluge  
*Internal fire extinguisher not activated  
 Flames only died out when oxygen system completely exhausted*

Chamber internal temperature estimated to have exceeded 1,000C/1,800F

Inadequate system maintenance; particularly O<sub>2</sub> delivery system cleanliness

No visible evidence of burns on deceased (hair/eyelashes intact)

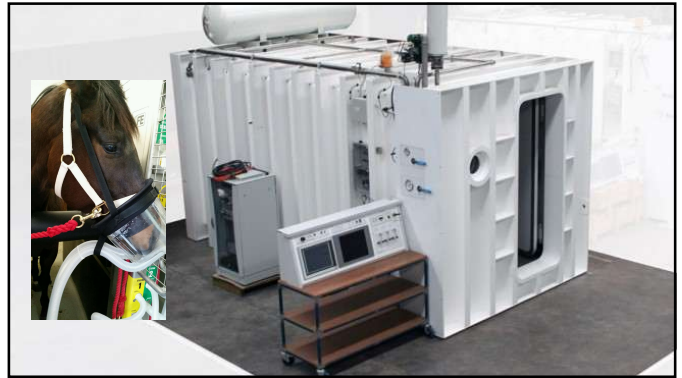
horse unsettled; kicking out

dislodged protective padding overlying steel hull

'massive spark' & flames per CCTV

Horse remained shod (steel)

His coat contained oil-based lotion

Formal training in hyperbaric technology/safety

Water deluge system?

Methane gas detector-chamber flushing issue?  
becomes explosive 5-17% range in air...? HBO  
loudest explosions >10% in air...? HBO
