Hyperbaric Chamber Fires: Lessons Learnt

Dick Clarke, CHT

Primary Training in Hyperbaric Medicine
Columbia, South Carolina

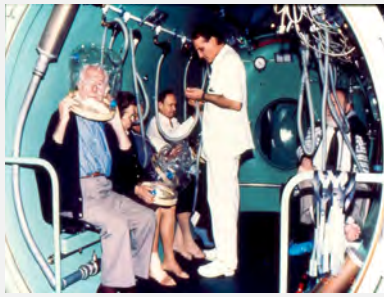
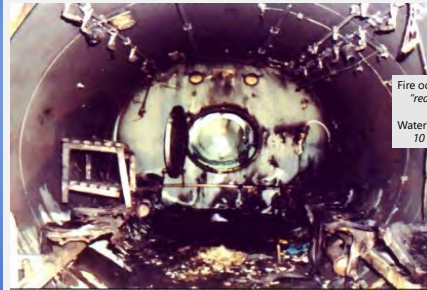
Multiplace chamber Milan, Italy
personal clothes; synthetics/pockets
no pt. or IA checks...pockets
hood exhaust system disconnected
"improperly modified hood latex neck seals allowed O2 to escape into pt. clothes making patients flammable cylinders"
chamber O2 concentration commonly exceeded permissible limit
"O2 monitor alarm manipulated"

Fire occurred during compression
"red flame explodes on screen, video goes black"
Water deluge system activated...no water emitted
10 pts 1 nurse quickly succumbed

"The fire extinguishing system was not functioning as the tank that was supposed to contain the water was empty, the propellant compressed air cylinder had the tap closed and the water supply hose valve was closed. The hand shower inside the hyperbaric chamber, foreseen in the design phase, had not been installed."

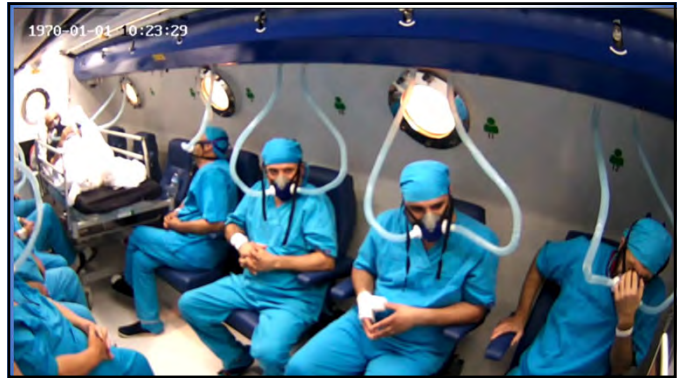
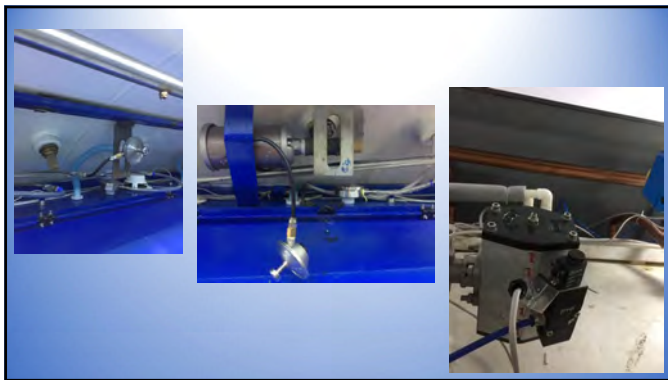
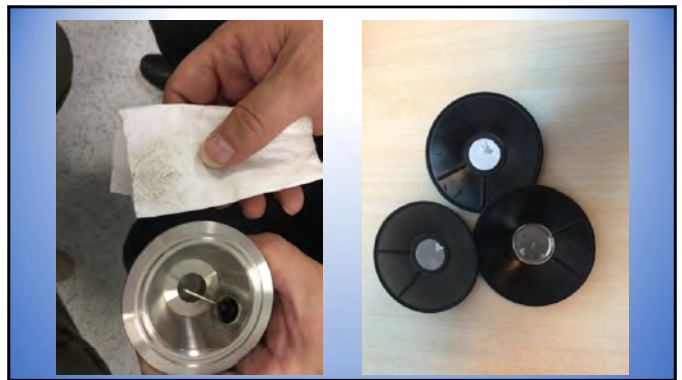
Multiplace chamber fire July 1998

3 fatalities: 2 divers, 1 physician

- Ongoing contamination O2 piping & valving; inadequate filtration
- Latter stages extended USN TT 6
- Chamber O2 atmosphere not monitored nor routinely flushed
 - one diver/pt. using mask with overboard exhaust, second using hood with inboard exhaust*
- Two "lightsaber-like" oxygen flames seen emitting (via viewport)
 - spontaneous ignition within regulators*
- Chamber operator did not/could not activate water deluge
 - internal fire extinguisher not activated*
 - Flames only died out when oxygen system exhausted*
- Relief valves lifted (10 ATA)

Inadequate system maintenance; particularly O2 delivery system cleanliness

Operational practices inconsistent with recognized standard of care

Physician entered chamber with cigarette lighter

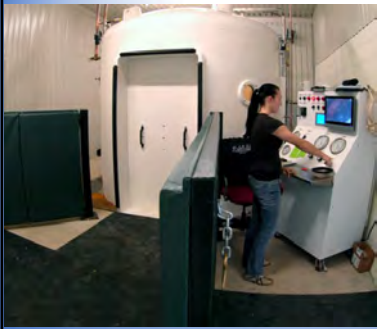
Steel oxygen-filled multiplace chamber

animal pt. fatality

chamber operator fatality

Patient treatment #5 underway

horse unsettled; kicking out

dislodged protective padding overlying steel hull

'massive spark' & flames per CCTV

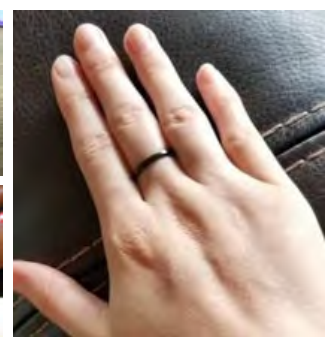
Scorched areas between creases at 4.0 mins.
