Hyperbaric Chamber Fires: Lessons Learnt

Dick Clarke, CHT

Primary Training in Hyperbaric Medicine
Columbia, South Carolina

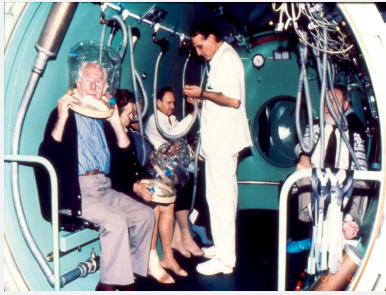
Multiplace chamber Milan, Italy
personal clothes; synthetics/pockets
no pt. or IA checks...pockets
hood exhaust system disconnected
"improperly modified hood latex seals allowed O2 to escape into pt. clothes making patients flammable cylinders"
chamber O2 concentration commonly exceeded permissible limit
"O2 monitor alarm manipulated"

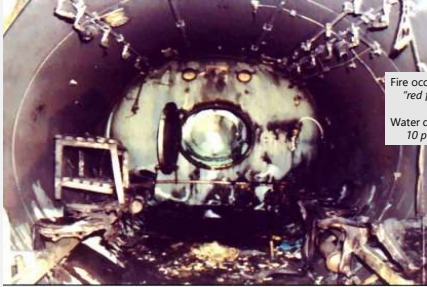
Fire occurred during compression
"red flame explodes on screen, video goes black"
Water deluge system activated...no water emitted
10 pts 1 nurse quickly succumbed

Fire lasted ~ 30 seconds

"The fire extinguishing system was not functioning as the tank that was supposed to contain the water was empty, the propellant compressed air cylinder had the tap closed and the water supply hose valve was closed. The hand shower inside the hyperbaric chamber, foreseen in the design phase, had not been installed."

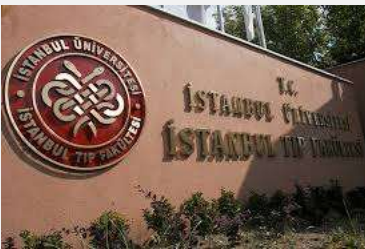
Istanbul University Medical Center
 Multiphase chamber fire July 1998
 3 fatalities: 2 divers, 1 physician

- Latter stages extended USN TT 6
- Chamber O₂ atmosphere not monitored nor routinely flushed
 one diver/pt. using mask with overboard exhaust, second using hood with inboard exhaust
- Two "lightsaber-like" oxygen flames seen emitting (via viewport)
 spontaneous ignition within regulators
- Chamber operator did not/could not activate water deluge
 Internal fire extinguisher not activated
 Flames only died out when oxygen system exhausted
- Relief valves lifted (10 ATA)

Inadequate system maintenance; particularly O2 delivery system cleanliness

Operational practices inconsistent with recognized standard of care

Physician entered chamber with cigarette lighter

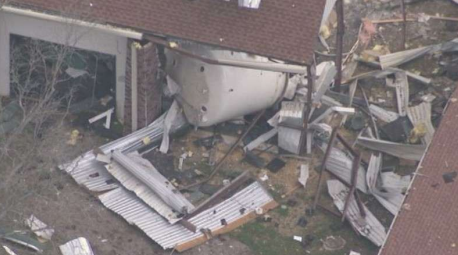
Assistant ran to alert fire service; heard two explosions

first smaller, followed in ~1 second by massive one, as chamber exploded

sound reported to have been heard several miles away

piece of chamber went through apartment window > 2 miles away

Operator (29 yo) died immediately, blunt force trauma/thermal injuries remains found buried under chamber debris

Horse remained shod (steel)

Not sedated

His coat contained oil-based lotion not washed with approved soap per FSP

No formal hyperbaric safety training

Formal training in hyperbaric technology/safety

Water deluge system?

Methane gas detector-chamber flushing issue? becomes explosive 5-17% range in air...? HBO loudest explosions >10% in air...? HBO
