Hyperbaric Chamber Fires: Lessons Learnt

Dick Clarke, CHT

Primary Training in Hyperbaric Medicine
Columbia, South Carolina

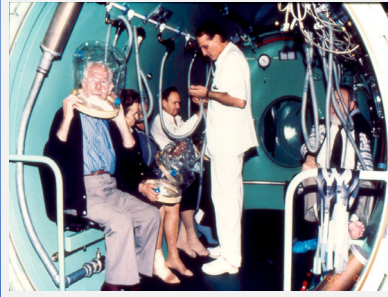
Multiplace chamber Milan, Italy

- personal clothes; synthetics/pockets no pt. or IA checks...pockets
- hood exhaust system disconnected
- "improperly modified hood latex neck seals allowed O2 to escape into pt. clothes making patients flammable cylinders"
- chamber O2 concentration commonly exceeded permissible limit
- "O2 monitor alarm manipulated"

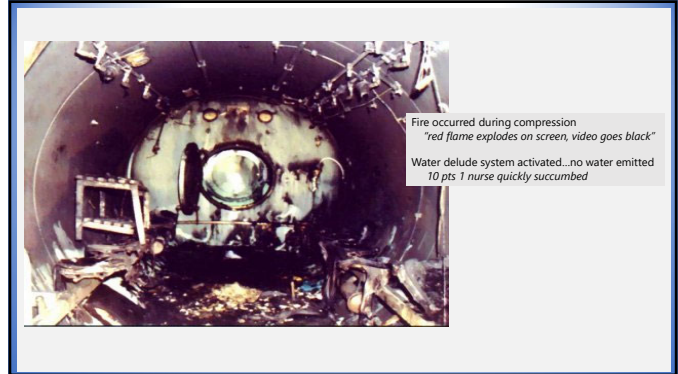
Fire occurred during compression
"red flame explodes on screen, video goes black"
Water deluge system activated...no water emitted
10 pts 1 nurse quickly succumbed

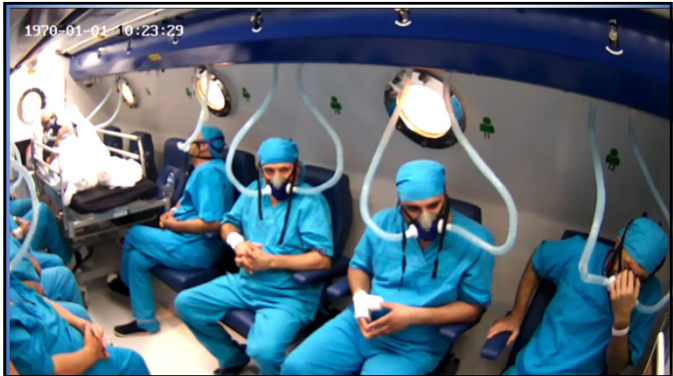
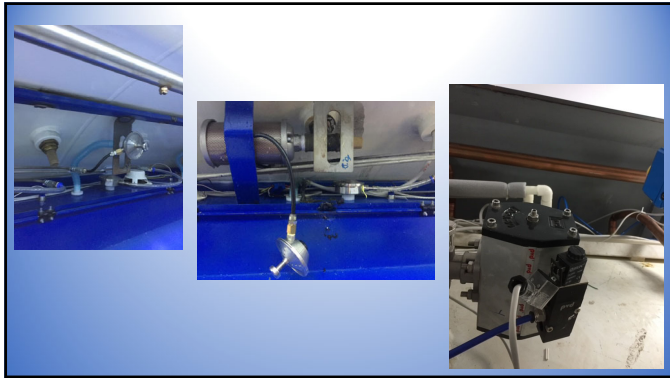
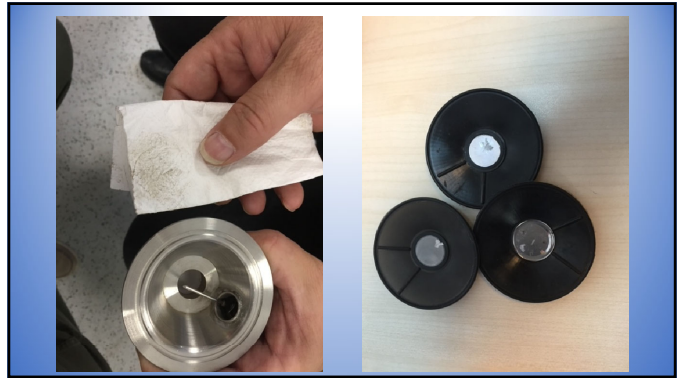
Multiplace chamber fire July 1998

- Ongoing contamination O₂ piping & valving; inadequate filtration
- Latter stages extended USN TT 6
- Chamber O₂ atmosphere not monitored nor routinely flushed
 - one diver/pt. using mask with overboard exhaust, second using hood with inboard exhaust*
- Two "lightsaber-like" oxygen flames seen emitting (via viewport)
 - spontaneous ignition within regulators*
- Chamber operator did not/could not activate water deluge
 - Internal fire extinguisher not activated*
- Relief valves lifted (10 ATA)

- Inadequate system maintenance; particularly O₂ delivery system cleanliness
- Operational practices inconsistent with recognized standard of care
- Physician entered chamber with cigarette lighter
 - "In all incidents I have encountered in my 30-year hyperbaric practice, the people who accidentally put a lighter or mobile phone inside are inside attendants and doctors, because patients are checked before each entrance"*
- Inadequate/non-existent emergency drills

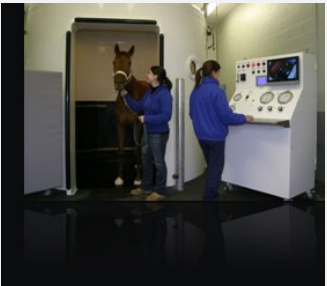
Steel oxygen-filled multiplace chamber
animal pt. fatality
chamber operator fatality

Patient treatment #5 underway
horse unsettled; kicking out
dislodged protective padding overlying steel hull
'massive spark' & flames per CCTV
urgent decompression initiated

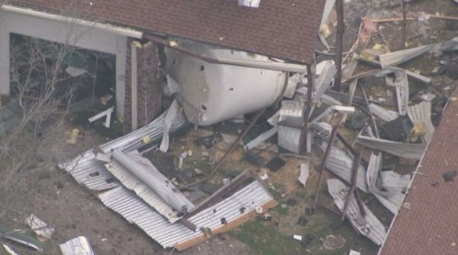
Assistant ran to alert fire service; heard two explosions
first smaller, followed in ~ 1 second by massive one, as chamber exploded
sound reported to have been heard several miles away
piece of chamber went through apartment window > 2 miles away

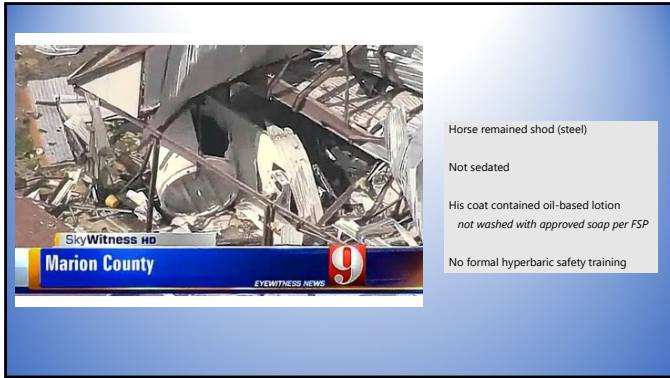
Horse remained shod (steel)
 Not sedated
 His coat contained oil-based lotion
not washed with approved soap per FSP
 No formal hyperbaric safety training
