Hyperbaric Chamber Fires: Lessons Learnt

Dick Clarke, CHT

Primary Training in Hyperbaric Medicine
Columbia, South Carolina

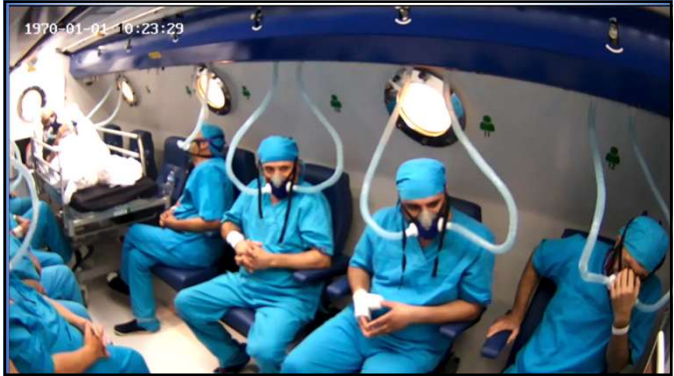
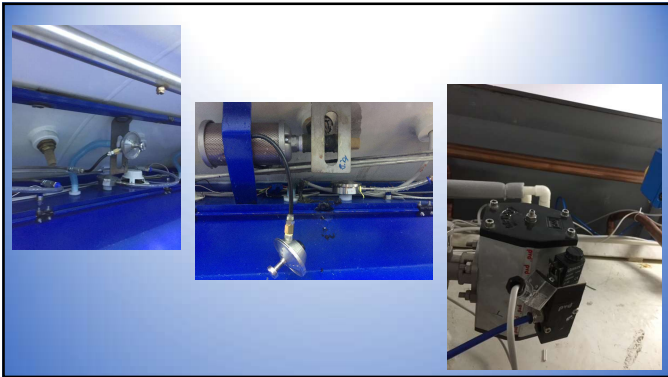
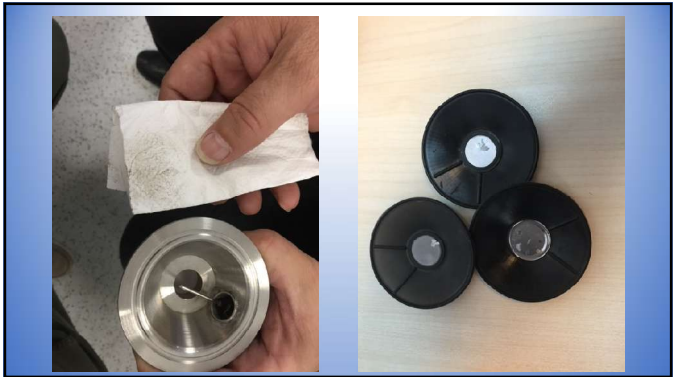
Inadequate/non-existent emergency drills

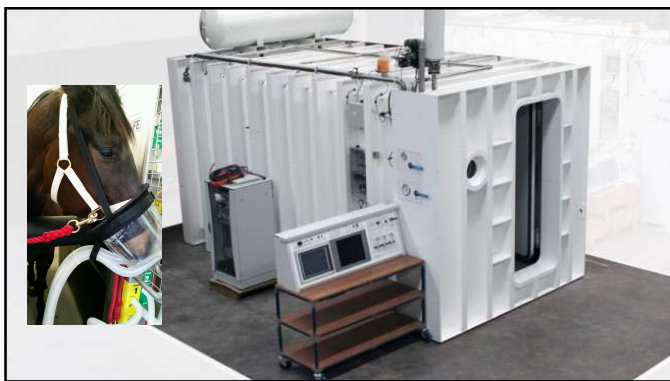
Water deluge system?

Methane gas detector-chamber flushing issue? becomes explosive 5-17% range in air...? HBO loudest explosions >10% in air...? HBO

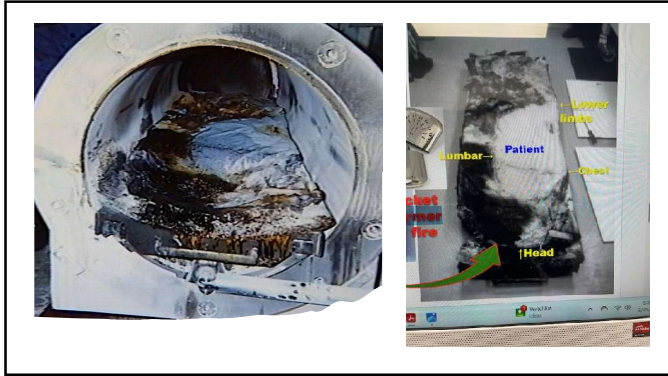
Year	Type Chamber	Fire/Explosion	Cause	Fire fighting	Severity of the injuries (if full body burn)
1967	Monophase (O ₂ compressed)	Fire	Ignition, closed pocket w/air	Unknown	1 patient died
1989	Monophase (O ₂ compressed)	Fire	Ignition, Plasma cath/ox w/air	Fire extinguisher	1 patient died
1992	Monophase (O ₂ compressed)	Fire	Ignition, Plasma cath/ox w/air	Fire extinguisher	1 patient died
1996	Monophase (O ₂ compressed)	Fire and Explosion	Ignition, Disposable pocket w/air	None	3 dead (1 patient / 2 others)

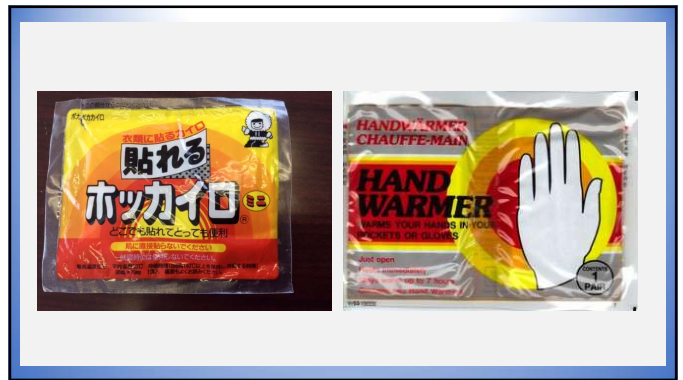
Oxer H. SPUMS Journal 1996;26(4)

Initial statement released by hospital was that all recommended safety procedures were carried out
