Hyperbaric Chamber Fires: Lessons Learnt

Dick Clarke, CHT

Primary Training in Hyperbaric Medicine
Columbia, South Carolina

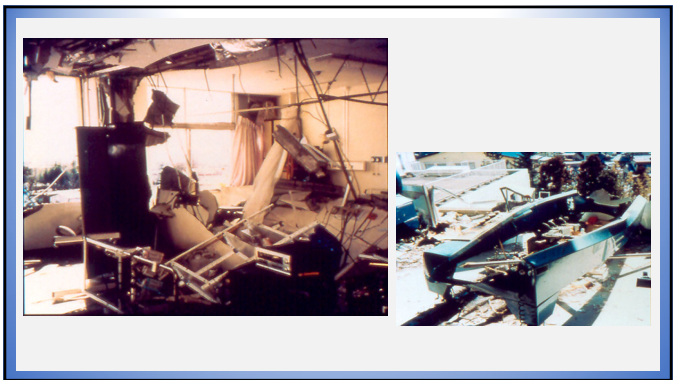
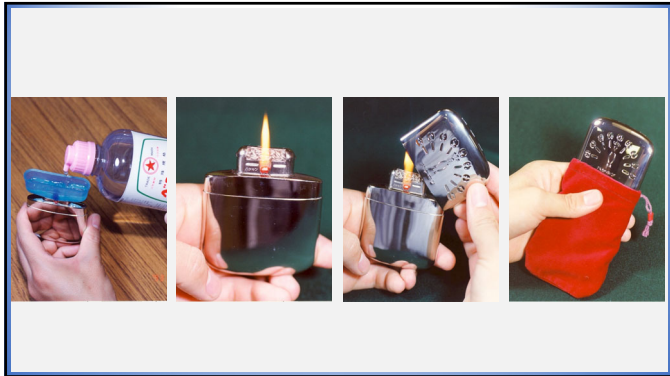
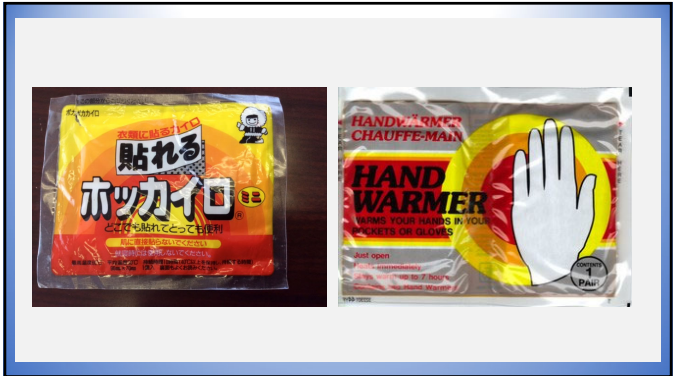
Operator (29 yo) died immediately; blunt force trauma/thermal injuries
remains found buried under chamber debris

Initial statement released by hospital that all recommended safety procedures were carried out
